12.0 Mexican Hat, Utah, Disposal Site

12.1 Compliance Summary

The Mexican Hat, Utah, Disposal Site, inspected on April 24, 2007, was in good condition. Runoff from storm events continues to transport sediment into the west diversion channel resulting in low-density vegetation growth within the entire length of the channel; however, the performance of the diversion channel has not been impaired. Tamarisk plants found on site were cut and treated with herbicide. Trash and tumbleweeds continue to accumulate on the site and along sections of the perimeter fence. A seismic monitoring station was installed inside the perimeter fence at the site as part of the EarthScope USArray Project; data will be collected for two to three years.

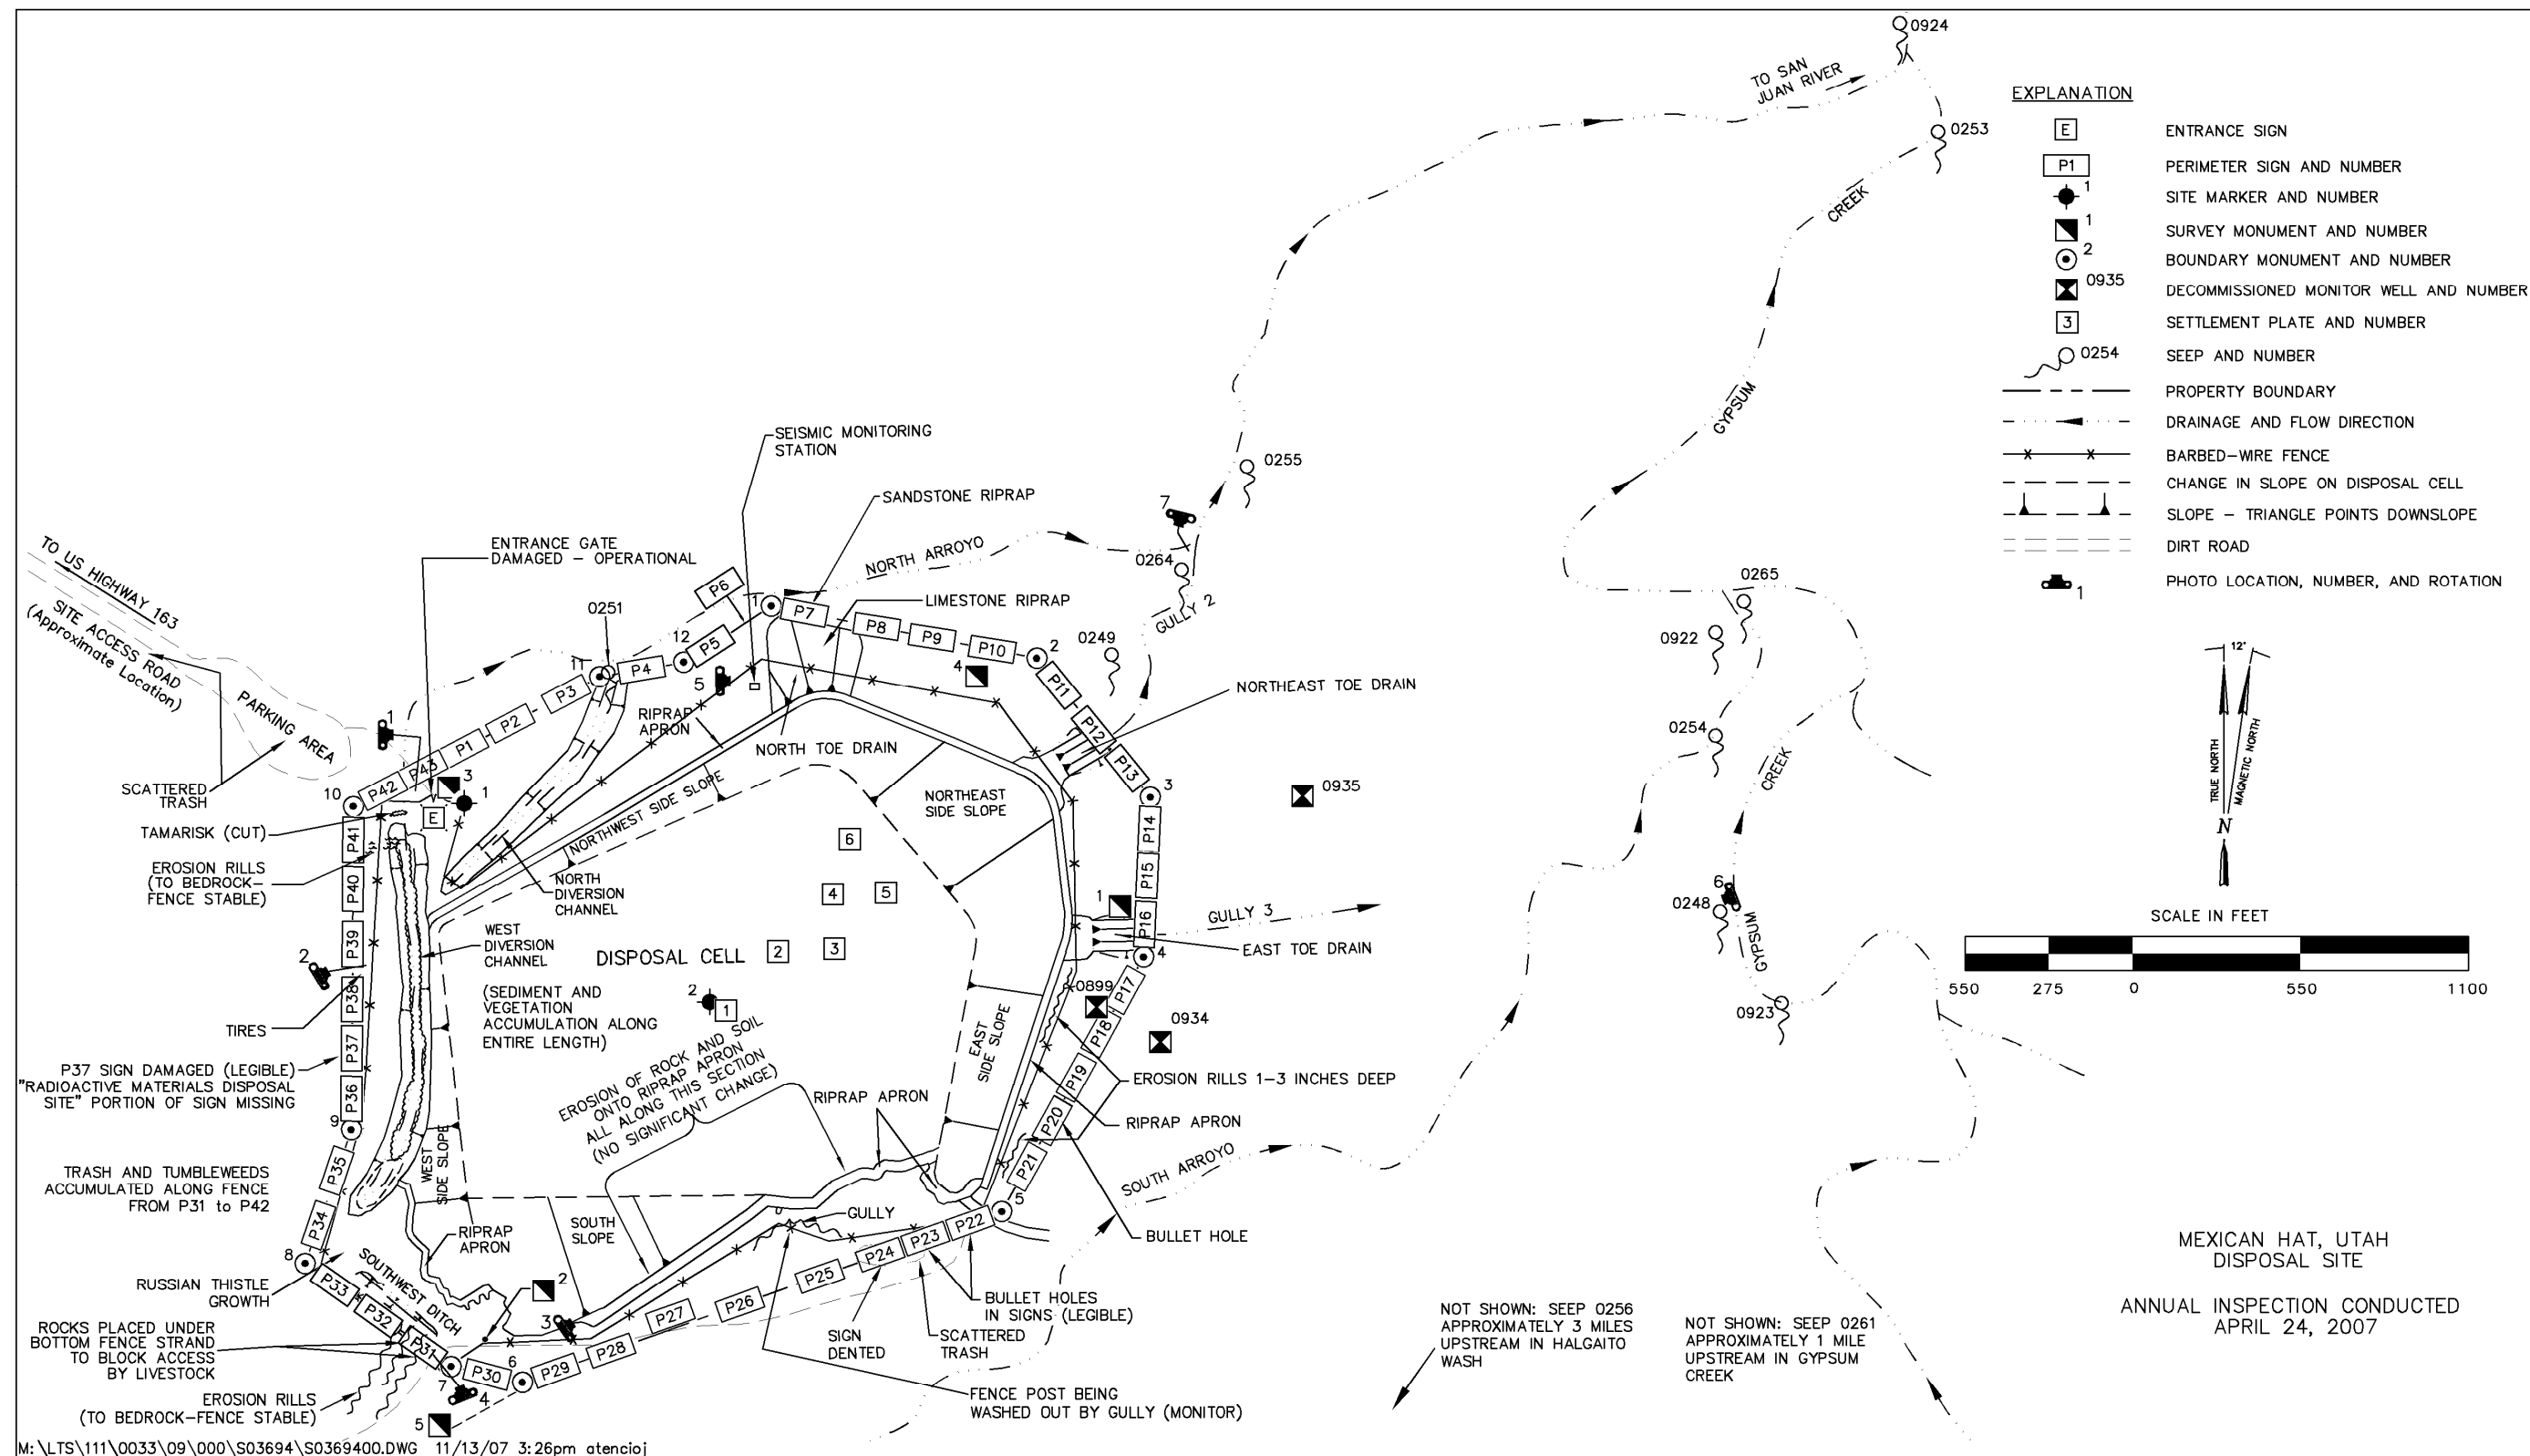
Figure 12-1. 2007 Annual Compliance Drawing for the Mexican Hat, Utah, Disposal Site

- 12A Monitor Wells**—The three monitor wells (MW-0899, MW-0934, and MW-0935) located on site and the one upgradient background monitor well located off-site (MW-0909) were decommissioned in April 2007 following concurrence by the Navajo Nation. Groundwater monitoring is not required by the LTSP under the current protection strategy and was only performed as a BMP due to concerns raised by the Navajo Nation.

- 12B** Tamarisk, an undesirable invasive shrub, was again found growing within the outlet of the west diversion channel, and was cut and treated with herbicide.

- 12C Scattered trash continues to accumulate in and adjacent to the site. Although most of the trash remains offsite, incremental trash removal on site will be performed as part of the annual inspections, as needed. Vehicle tracks continue to be observed in the areas between the perimeter fence and the site boundary, indicating occasional trespass onto the disposal site property. Trash accumulations and trespassing will continue to be monitored; currently, they are not affecting the integrity of the site.
